DAMAGES CAUSED BY CYCLONIC STORM AND REMEDIAL MEASURES AT TUTICORIN PORT

T. Janakaraj Thomas and P.R. Mani
Tuticorin Port Trust
Tuticorin - 628 004, India
Fax : (0461) 52301; e.mail:tpt @ 400 nicgw.nic.in

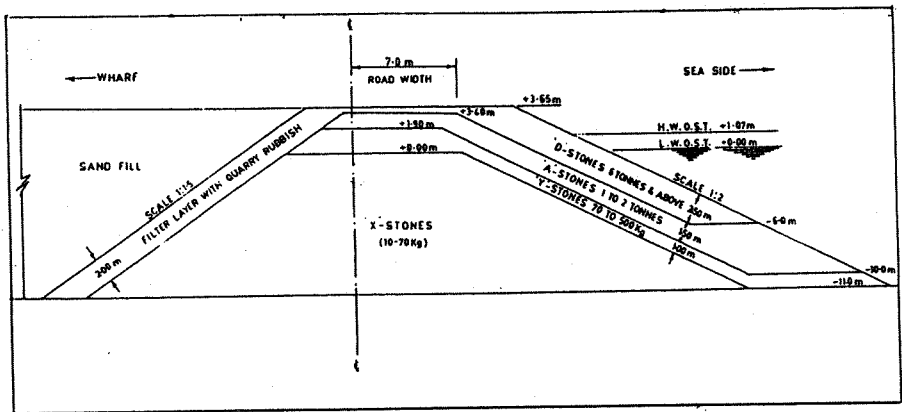
Fig.5 Cross section of eastern breakwater

executed in shown in Fig. 5. Consequent to the decision, the construction of parapet wall over the EBW was deferred. During the watch period of 5 years and another 14 years totalling 19 years there was no effect due to the cyclonic storms that normally passed between Pamban and Tuticorin till the storm that passed directly over Tuticorin on 13.11.1992. The previously recorded storm affecting Tuticorin was observed in the year 1961 i.e., before physical planning of the major port.

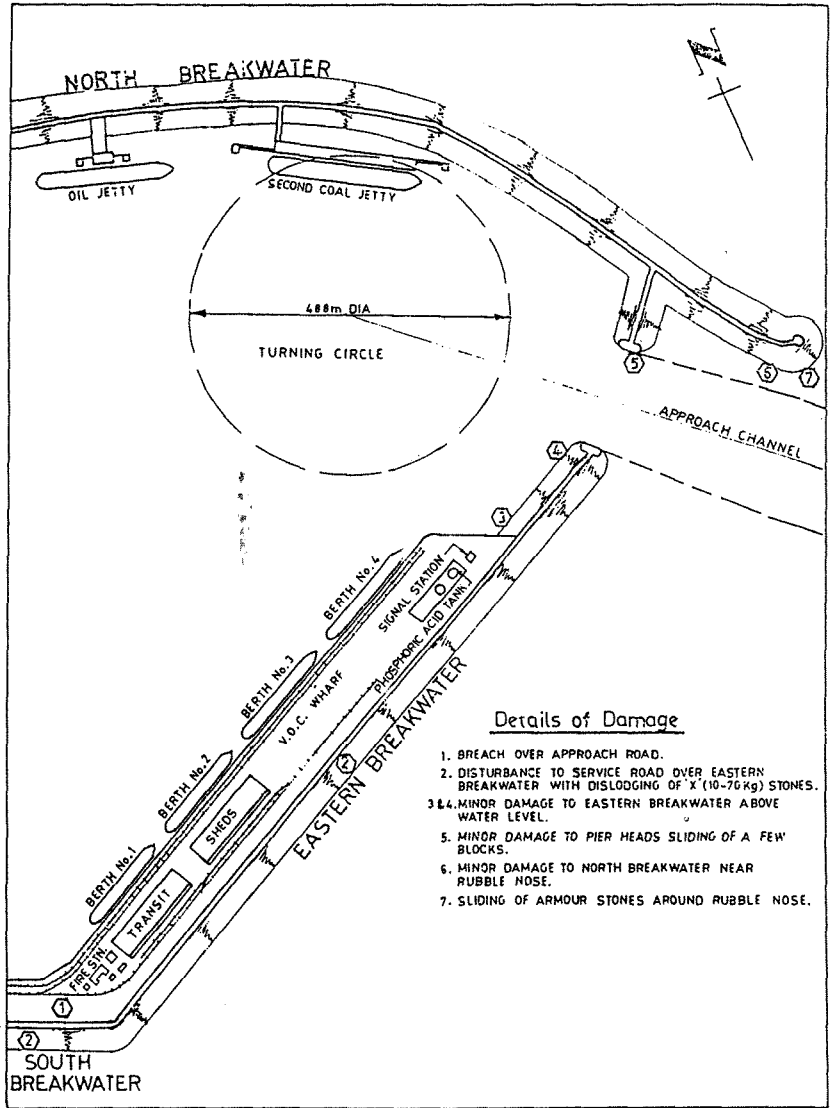
Fig.6 Damages due to storm

surge aggregating to the height of about 4.5 m to 5.0 m might have been the cause for such a quantum of overtopping on the eastern arm of SBW. A sheet of about 1 to 1.5 m thick water passed over the VOC wharf tossing the stacked container boxes here and there. The B.T road atop the Eastern Breakwater and the formation stones (10-70 kg.) got dislodged for depth of about 0.3 m - 0.5 m. There was a breach at the junction of the approach arm and the VOC wharf causing temporary suspension of the road transport to the VOC wharf and vice versa. In the eastern breakwater armour stones were disturbed in three locations for lengths of 20 m to 30 m upto the water level.

A few concrete blocks at the entrance pier heads found slid causing minor damages, so also the blocks around the rubble nose of the north breakwater. On account of cyclone, navigation remained temporarily suspended to ensure safety of vessels. A sketch showing damages in the breakwaters and wharves is shown in Fig.6.

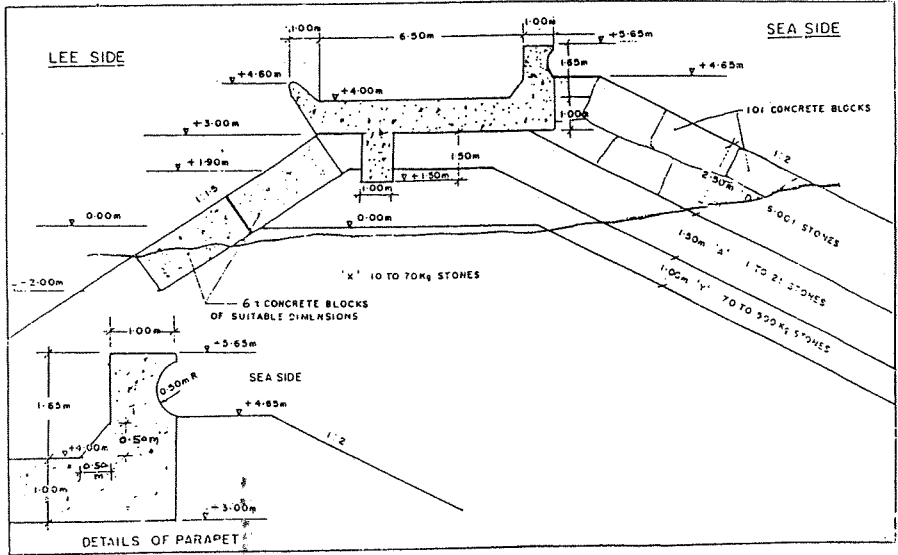
Fig.7 Measures to repair eastern breakwater

In the CWPRS, the wave that could have occurred during the storm was hindcasted with the available data such as synoptic charts and storm tracks from the Indian Meteorological Department, Pune. Flume tests were conducted on the cross sections of the breakwaters/pier heads to evolve suitable armouring system with rock boulders or concrete blocks/tetrapods. It was then decided that a storm surge of about 0.5 m would have occurred coinciding with the high water level during the passage of cyclone on 13.11.1992 and the external wave height would have been around 4.2 m.

To strengthen the existing breakwater for protection against future similar cyclones, the CWPRS proposed the Eastern breakwater be provided with the curved parapet with top elevation at +5.65 m as shown in Fig.7 with 10T concrete blocks on the sea side (with slope 1:2) and 6T blocks on the Lee side side (with slope 1:1.5). The parapet would be laid monolith with a roadway of 6.5 m wide and a lip on the road over breakwater and with necessary drainage arrangements. The section has been found to be safe with 1% damage to the 10T and 6T concrete blocks for HWL of +1.07 m and 4.2 m waves with 0.5 m storm surge with certain overtopping conditions. However, the cross section as such was found stable for storm duration.

The section so constructed was previously studied by the CWPRS in wave flume for waves of 3.8 m and 4.2 m with storm surges of 0.5 m and 1.0 m. With 3.8 m waves there was practically no damage at all water levels. With 4.2 m waves there was no damage at low and high water levels. However, with the storm surge and high water there was damage to the main armour by way of disturbance to the blocks placed in slope, but the lee of the rubble nose was not affected. As such, modified sections were again tested in the wave flume and the acceptable section communicated for execution.

The strengthening measures to the EBW (with curved parapet wall cum roadway) and to the rubble nose of the NBW were taken up and executed before the on-set of the monsoon of the year 1994.
