TECHNICAL REPORT REMR-CO-3

CASE HISTORIES OF CORPS BREAKWATER
AND JETTY STRUCTURES

Report 9

SOUTHWESTERN DIVISION

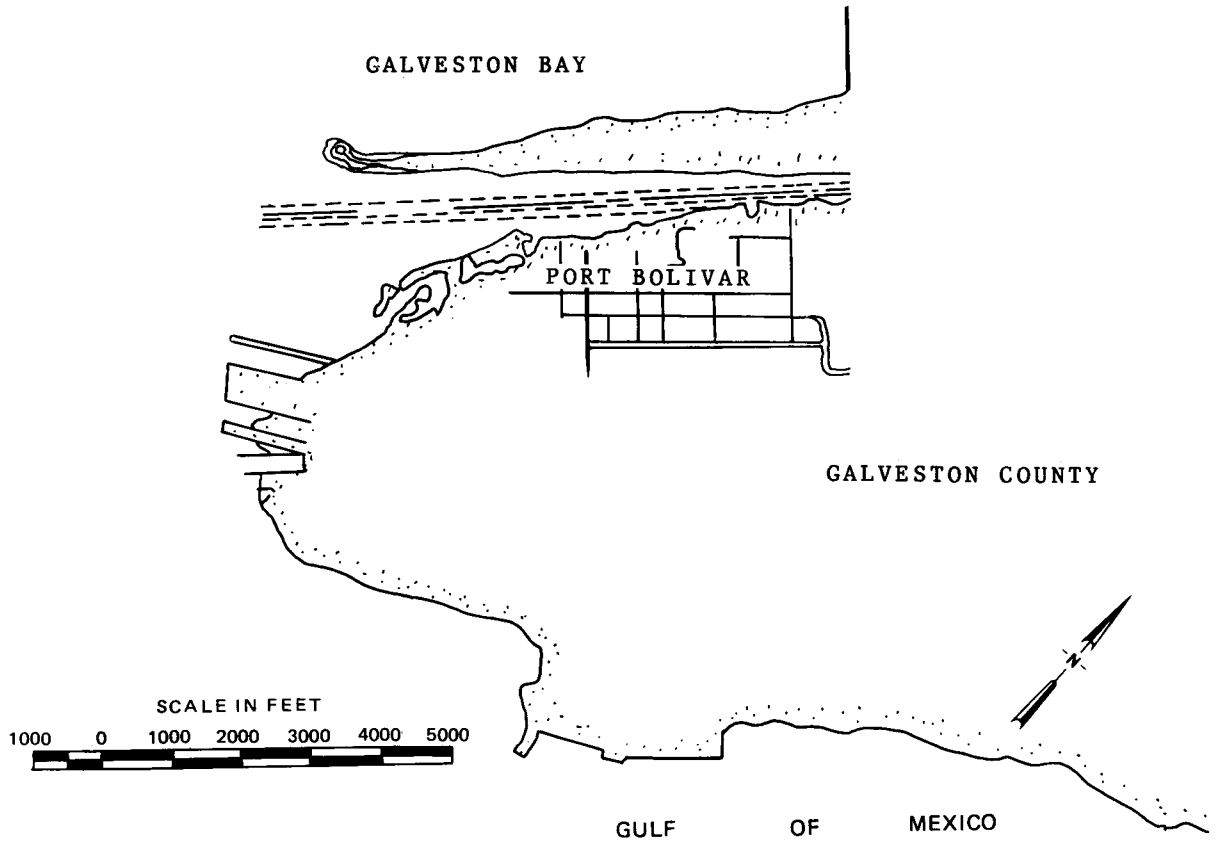
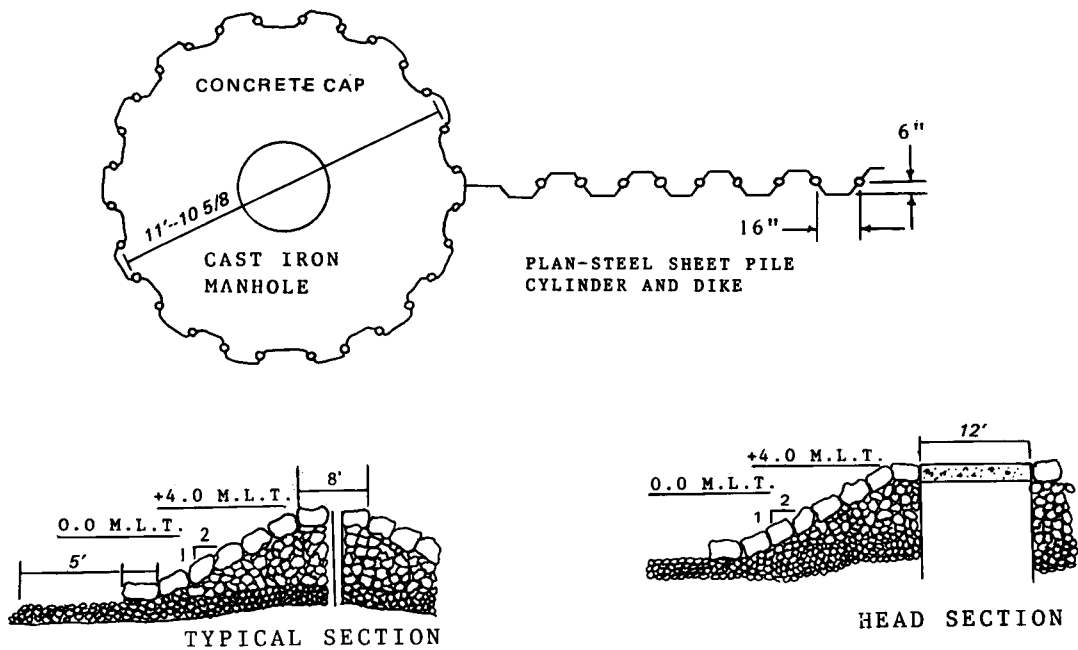
<u>Date(s)</u>	<u>Construction and Rehabilitation History</u>
1933- 1934	A 1,700-ft-long steel sheet-pile dike was constructed to prevent shoaling in the Gulf Intracoastal Waterway at this location (Figure 3). The seaward end of the dike consisted of a 12-ft-diam sheet-pile cell, with a 2-ft-thick concrete cap (and underlying fill material), protected by a stone blanket at the toe of the cell. The top elevation of the sheet pile was +4 ft mlt. Existing water depths varied from -4 (landward) to -13 (seaward) ft mlt. A total of 47,500 sq ft of sheet pile and 6,670 tons of stone was used. Cost of the improvements was \$25,000.
1936- 1937	The landward end of the dike was repaired and extended 200 ft at a cost of \$7,050. Approximately 230 tons of stone was placed as scour protection at the seaward end at a cost of \$1,750.
1966	The outer 1,230 lin ft of sheet pile was supplemented with a rubble-mound section similar to the 1964-1965 Port O'Connor repairs. The dike was generally intact, with some damage to the piling at the outer end and a heavy coating of rust scale due to saltwater exposure. Existing ground elevations varied from -5 ft mlt near the seaward end to +4 ft mlt along the unrepaired landward segment (in general, an accretion of 6 to 8 ft had occurred since original construction). The outer sheet-pile cell, with a maximum water depth of -11 ft mlt, was the only section where localized scour was evident (but in this case not critical to structural integrity). The sheet-pile top elevation was generally from +3.5 to +4 ft mlt (within 0.5 ft of the design elevation). The rubble-mound design sections (Figure 3, inset), with the existing dike at the center line, had a crown elevation varying from +4 (seaward) to +6 (landward) ft mlt, a crown width of approximately 8 ft (2 cover stones wide) and 1V:2H side slopes. The sections were built upon a 2-ft-thick (3 ft at outer end) bedding layer of 0.5-in. to 200-lb stone. The bedding layer extended from 3 ft (landward) to 10 ft (seaward) beyond the toe of the cover layer and was covered with a 2-ft-thick layer of 200- to 1,000-lb apron stone. Similar sized stone were used as core stone, and the outer layer consisted of 1- to 6-ton stone. Filler stone (0.5 to 4 in.) also were placed with the core stone, in a section extending beneath the crown at 1V:1H side slopes. The general purpose of filler stone is to decrease permeability and reduce sediment transport through the structure. The cover stone size was selected based partly on Hudson's slope stability equation and partly for economic reasons. A total of 19,280 tons of stone was placed at a cost of \$164,700.

1985	The dike presently is considered to be in good condition.

Figure 3. Location, plan view, and typical sections of Port Bolivar jetty
