Reconstruction of breakwater in Arzew, Algeria

Client: Ministry of Public Works, Directorate for Basic Infrastructure
 Engineer: Nedeco (Netherlands)
 Location: Mediterranean Coast, Arzew (El Djedid), Algeria
 Period: 1986 – 1992

Introduction

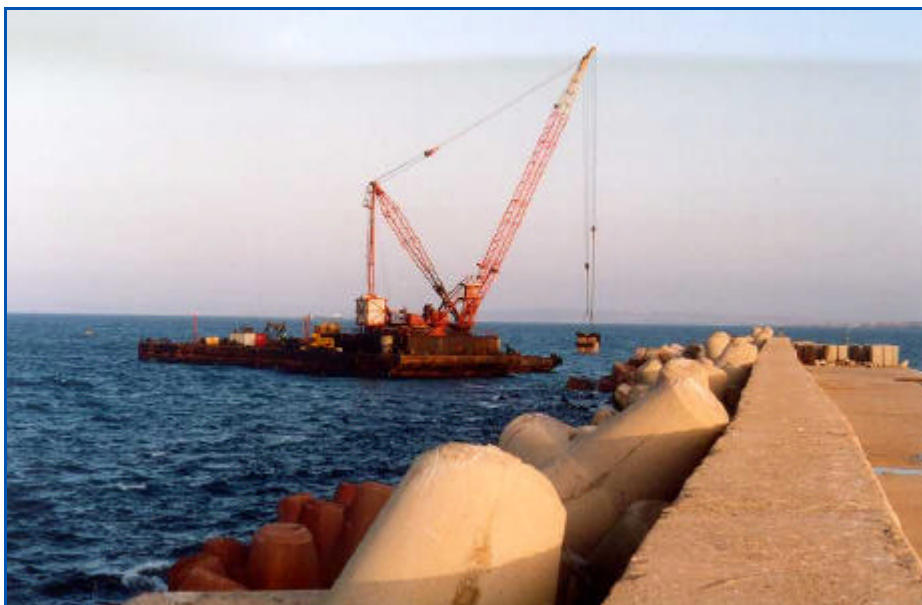
Left: placement of concrete elements;
 Right: summary of quantities.

150.000	m ² seabed clearance
115	mattresses, each measuring 30x50 metres
1.000.000	tons of quarry run
4.00.000	tons of filter stone, of 10-60 kg and 60-300 kg
3.00.000	tons of 0.2-1 ton rocks
4.00.000	tons of 1-3 ton rocks
7.00.000	tons of 4-6 ton rocks
19.000	concrete blocks of 12 tons each
22.000	concrete blocks of 40 tons each
1.500	concrete blocks of 60-65 tons each

stone and rock it was possible to start placing the concrete blocks. A total of 19.000 blocks (12 tons each) were placed along the toe of the breakwater using the floating crane and, partly, the stone dumper. For the breakwater slopes and the two ends, 22.000 larger concrete blocks of 40 tons each were placed, supplemented at both ends of the structure with 1.500 blocks of 60-65 tons each.

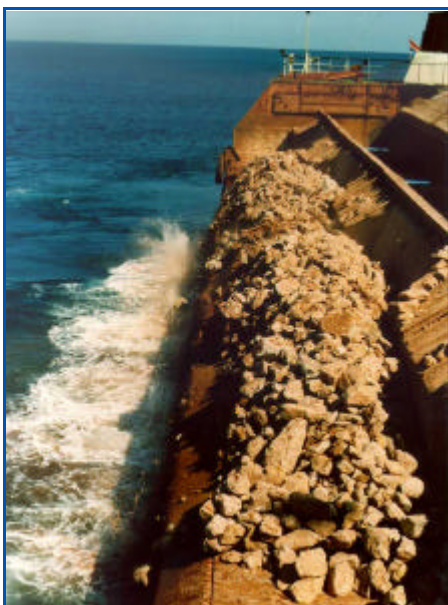
Left: spreading of filter stone;
Middle above: scheme of reconstruction of toe;
Middle under: Scheme of placement of concrete elements;
Right: handling of 65 tons elements.

With these initial stages of the project completed, reconstruction could begin in earnest. Some 400.000 tons of filter stone, of 10-60 kg and 60-300kg, was spread over the mattresses, followed by almost 400.000 tons of rock (weighing 1-3 tons) which formed the toe of the new breakwater construction. Next came 650.000 tons of quarry run, to build up the required breakwater profile, followed by 300.000 tons of 0.2-1 ton rocks and 700.000 tons of 4-6 ton rocks. All grades of material were placed within the tight tolerances stipulated in the design. During placement of the
